ARMY MATERIEL SYSTEMS ANALYSIS ACTIVITY ABERDEEN PROV--ETC F/G 9/5  
WATER ENTRY INTO THE MX-6707/VRC ANTENNA MATCHING UNIT-BASE.(U)

AMSAA-TR-364

4. TITLE (and Subtitle) Water Entry Into the MX-6707/VRC Antenna Matching Unit-Base		5. TYPE OF REPORT & PERIOD COVERED
7. AUTHOR(s) Harry N. Harris		6. PERFORMING ORG. REPORT NUMBER

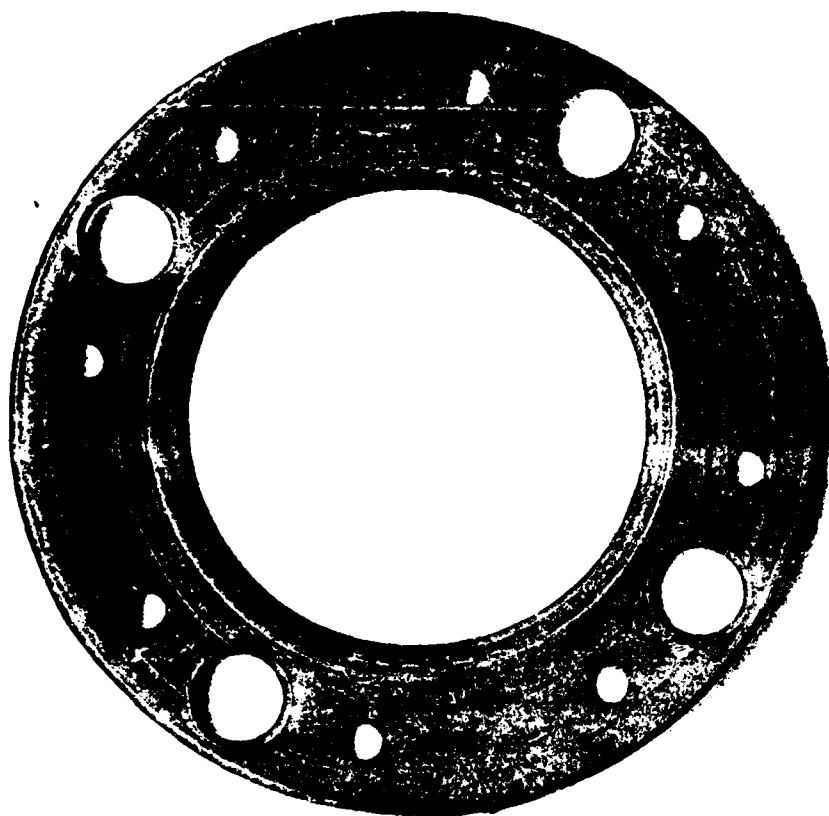
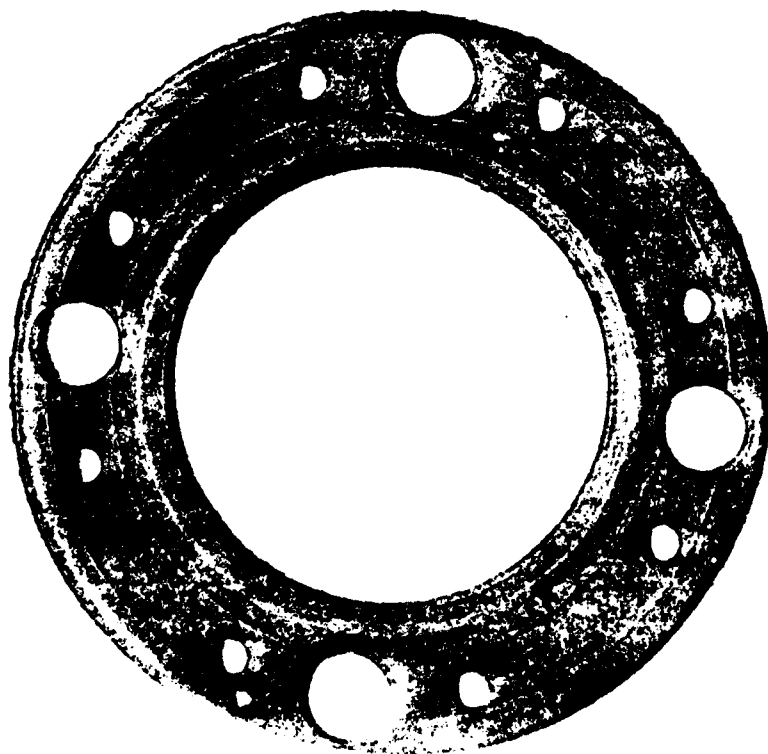
FIGURE G1 - GASKET DAMAGE

RIGHT - USED

LEFT - NEW

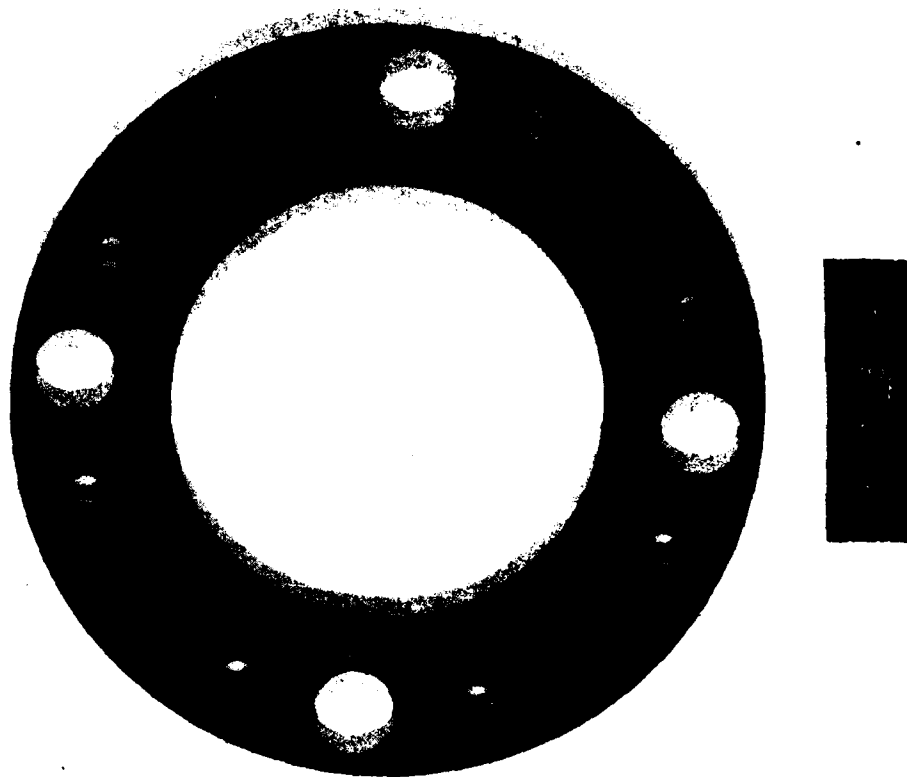
FIGURE I3 - SPECIAL GASKET

After the elevated temperature test, the gaskets were examined. The anticapillary gasket had permanently stretched, increasing its diameter by 3/8-inch (see Appendix I, Figure I3). The cause is believed to be due to the elevated temperature and flange compression of the gasket. If the anticapillary gasket, between the top and bottom sections of the matching unit, is sticking out around the edges, it may be crushed and thus not doing its job; therefore, it should be changed. In talks with personnel at CORADCOM (Ft. Monmouth, NJ), it was learned that the gaskets, manufactured by Hy-Gain (Div. of Telex Communications, Inc.), had a thin coat of silicone spread on them. It was stated that the type of silicone grease causes the rubber gasket to expand under heat. At first, it was suggested that the gasket be made of neoprene rubber instead of silicone rubber. Neoprene has good resistance to weathering and oil. Its aging properties are superior to those of natural rubber and it has good resistance to heat. (2) It was later noted that neoprene hardens

at cold temperatures and presents problems. Too much silicone grease put on a gasket that is placed in a hot temperature environment, causes an outward force that creates a round, or bulging, effect. Luckily, a crosswise split does not develop since it would allow water entry.

When the gasket was coated with a thin film of silicone compound, subjected to "hot" conditioning, and then immersed in the dye solution for two hours, the gasket permanently stretched, increasing in diameter by 3/8-inch. It is suggested that alternate gasket materials be evaluated for greater resiliency and resistance to thermal distortion and that the properties of the silicone compound be examined so that the correct type of compound can be applied.
